Collision with terrain involving Lockheed EC130Q, N134CG

50 km north-east of Cooma-Snowy Mountains Airport (near Peak View), NSW, on
23 January 2020

ATSB Transport Safety Report

AO-2020-007

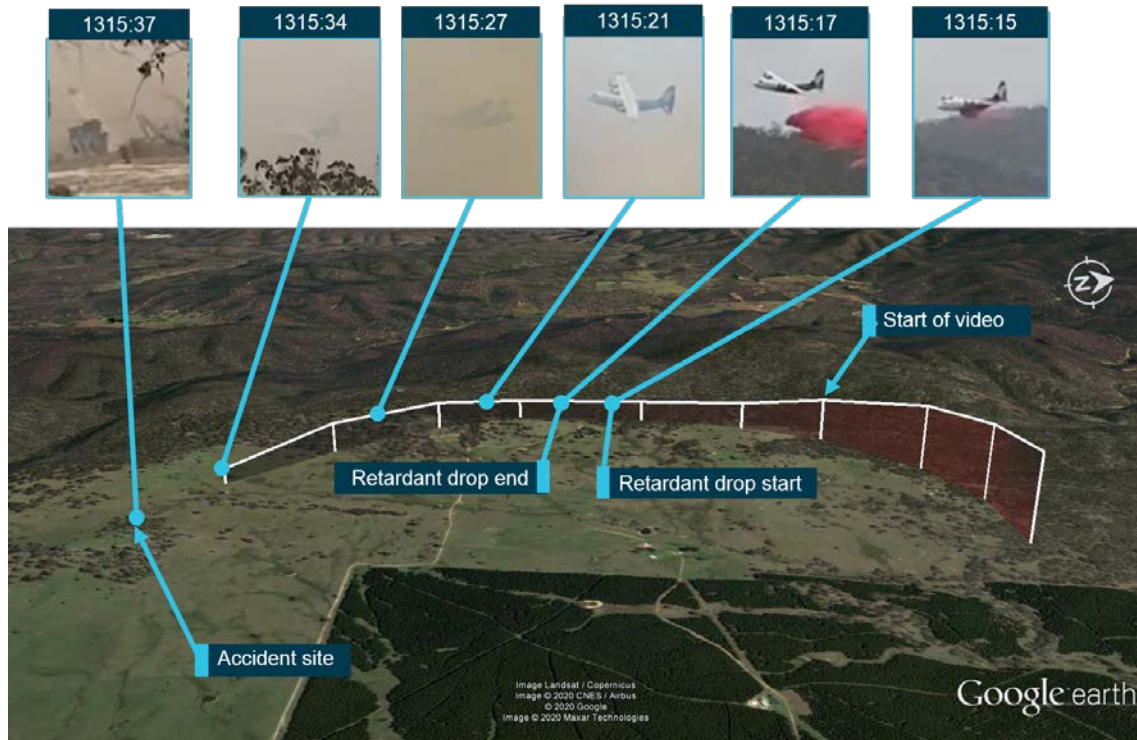
Figure 3: Aircraft attitude and approximate flight path at key times

The ATSB’s analysis of the witness videos found that, at the completion of the drop at 1315:17, the aircraft was observed to be banked about 17° to the left (Figure 3). About 4 seconds after the drop at 1315:21, the aircraft had a pitch-up attitude of about 12°, with an increase to about 30° angle of bank. Over the next 1.5 seconds, the aircraft’s angle of bank and pitch attitude reduced to about 22° and 10° respectively. The aircraft then became obscured by smoke.¹³

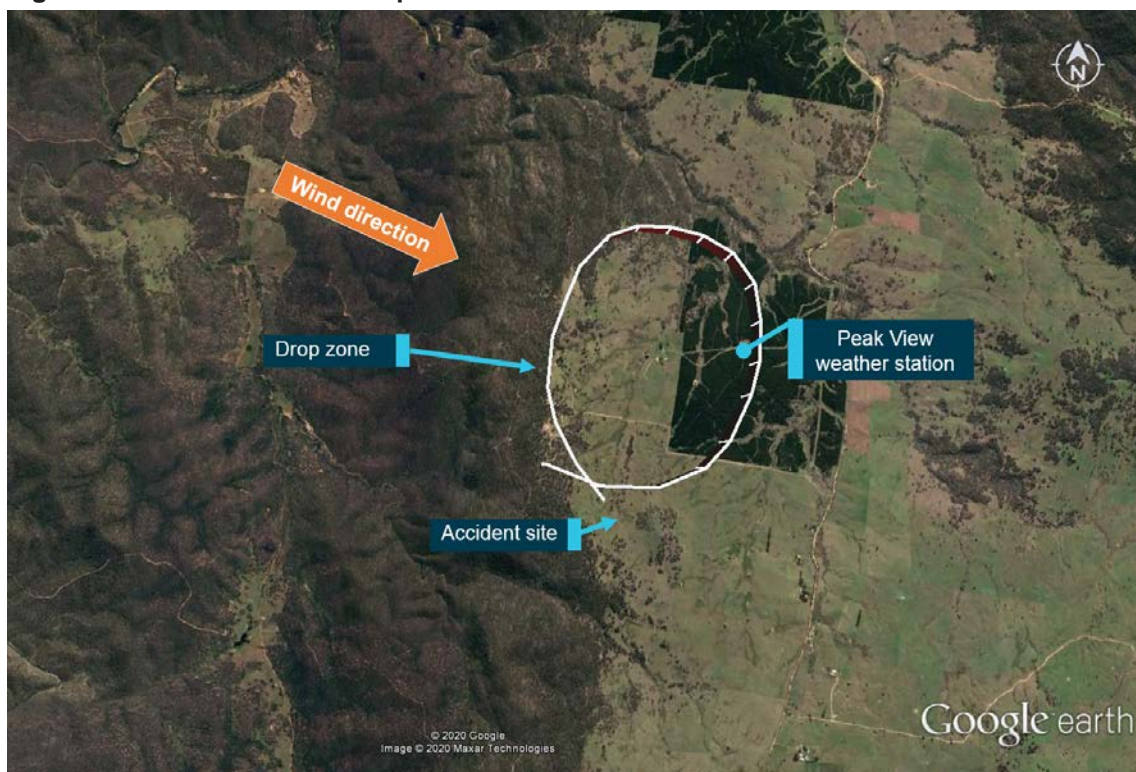
Figure 5: Accident circuit with predominant wind direction and terrain

A personal weather station at Peak View, located about 1.3 km from both the drop and accident sites (Figure 5) recorded the conditions twice per hour. At about 1309 (7 minutes prior to the accident), the station recorded a mean wind of 15 kt from the west and a peak gust of 32 kt from the north.²⁸ At about 1330 (14 minutes after the accident), the station recorded a mean wind of 16 kt from the west and a peak gust of 42 kt from the north-west.

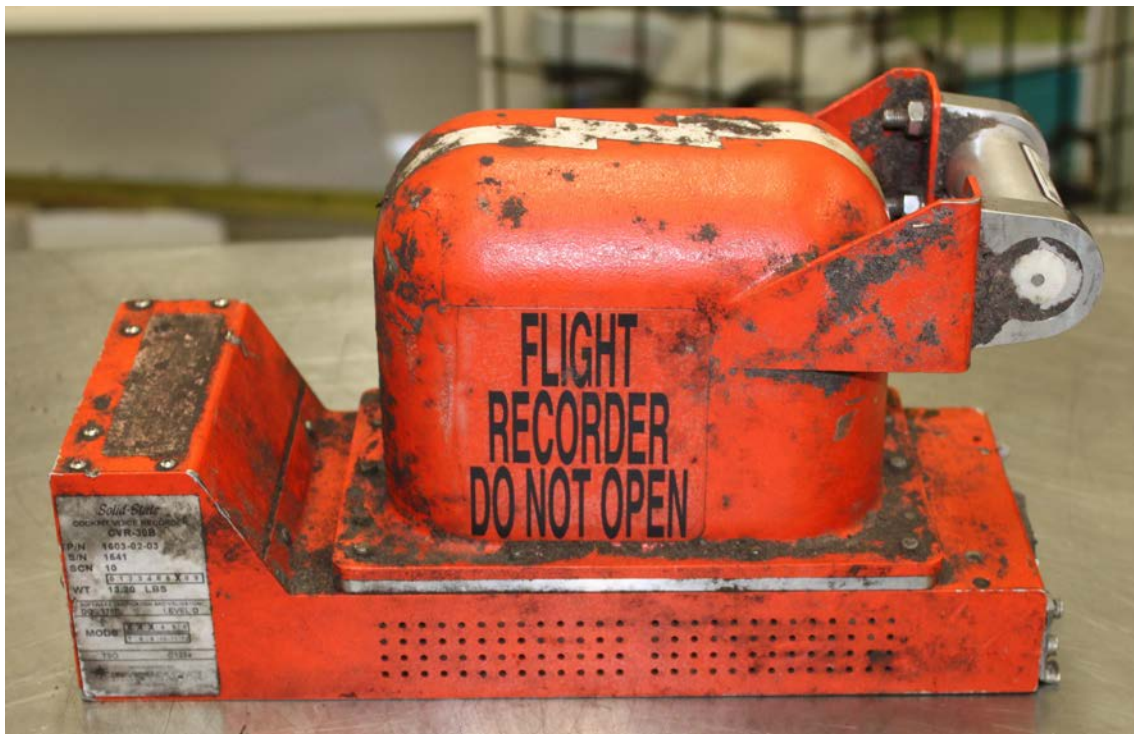
Figure 6: N134CG cockpit voice recorder

The CVR was recovered from the aircraft and transported to the ATSB's technical facility in Canberra, Australian Capital Territory, on 25 January 2020 for examination and download. The CVR was successfully downloaded, and the recording downloaded contained 31 minutes of audio. However, the audio was from a previous flight when the aircraft was operating in the US. No audio from the accident flight was recorded on the CVR.

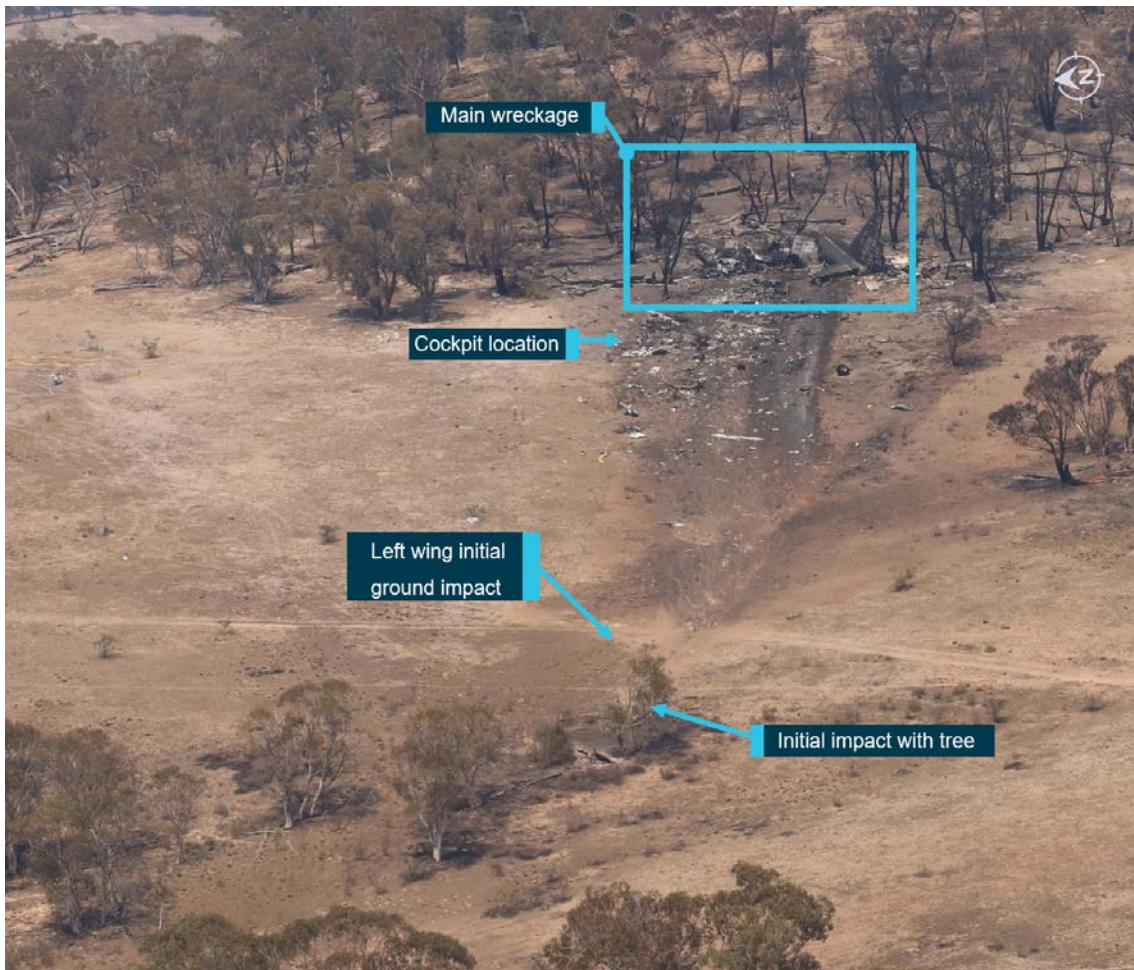
Figure 7: Accident site overview showing the wreckage trail

The accident site was located on slightly sloping, partially wooded terrain, near Peak View, 50 km north-east of Cooma-Snowy Mountains Airport. The wreckage trail (Figure 7) was approximately on a heading of 100°, with the initial impact at an elevation of about 3,440 ft AMSL. The debris trail began at the lower end of the slope, with the wreckage distributed linearly over about 180 m.

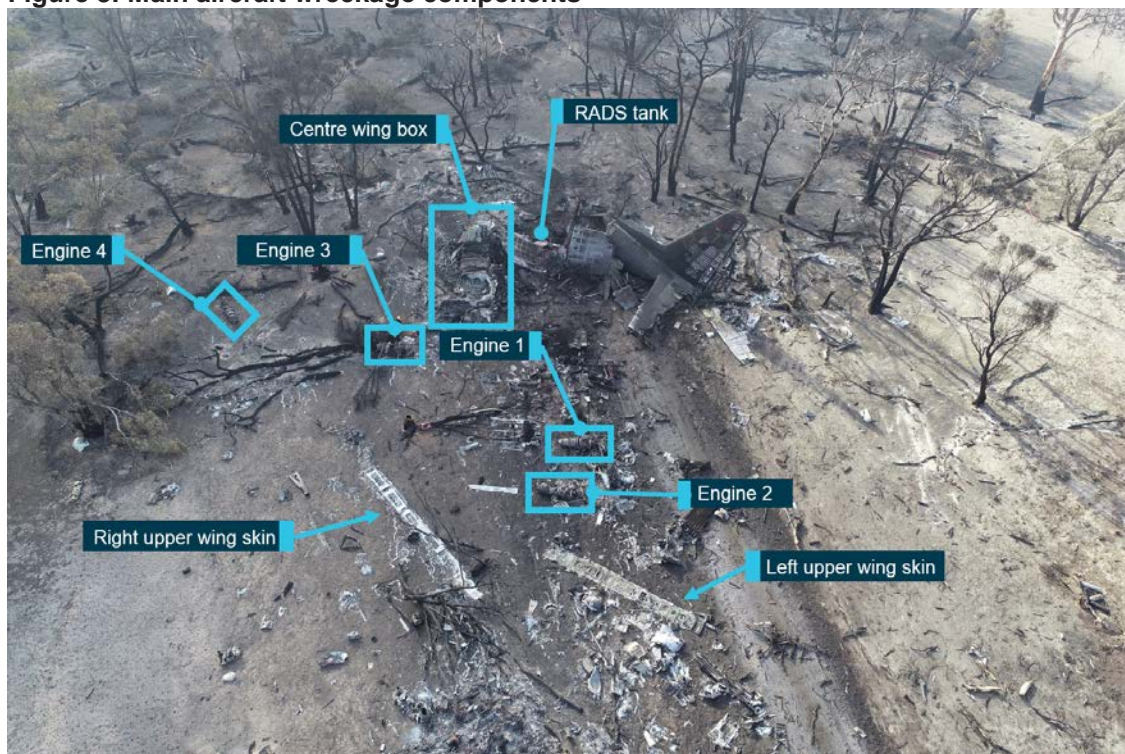
Figure 8: Main aircraft wreckage components

The ATSB's on-site examination of the wreckage, damage to the surrounding vegetation, and ground markings, indicated that the aircraft initially impacted a tree in a left wing down attitude, of about 55°, before colliding with the ground. An intense post-impact fuel-fed fire destroyed the aircraft. The ATSB's on-site examination (Figure 8) also found:

- no pre-existing airframe issues
- all major sections of the aircraft's structure were identified and there was no evidence of an in-flight break-up or pre-impact structural damage²⁹
- the cockpit and associated avionics were identified about two-thirds of the way along the wreckage trail
- the cockpit and forward section of the airframe had separated from the fuselage, was inverted, and had been destroyed in the impact and subsequent fire
- sections of the wing skin, leading edge spar, wing tips and portions of the wings were identified along the wreckage trail, having fragmented during the impact sequence, and sustained further damage during the resultant fire

- all flight control surfaces were identified, however, due to the impact and fire, flight control continuity could not be established
- the four engines and 16 propeller blades were located on-site and some of the propeller blades remained attached to the propeller hubs, while others had detached through impact forces
- there were varying degrees of damage observed across the four engines, likely due to the impact sequence of each engine, with the damage indicating the engines were rotating at impact.

The RADS tank remained upright (Figure 8), along with the aft section of the fuselage, with the vertical and horizontal stabilisers attached. There was no retardant identified between the drop area and the initial impact location, however, a large amount of retardant was located in the wreckage near the tank. The system was badly damaged, with the doors fragmented throughout the wreckage, and its operational state could not be established.
