Collision with terrain involving Lockheed EC130Q, N134CG

50 km north-east of Cooma-Snowy Mountains Airport (near Peak View), NSW, on
23 January 2020

ATSB Transport Safety Report

AO-2020-007

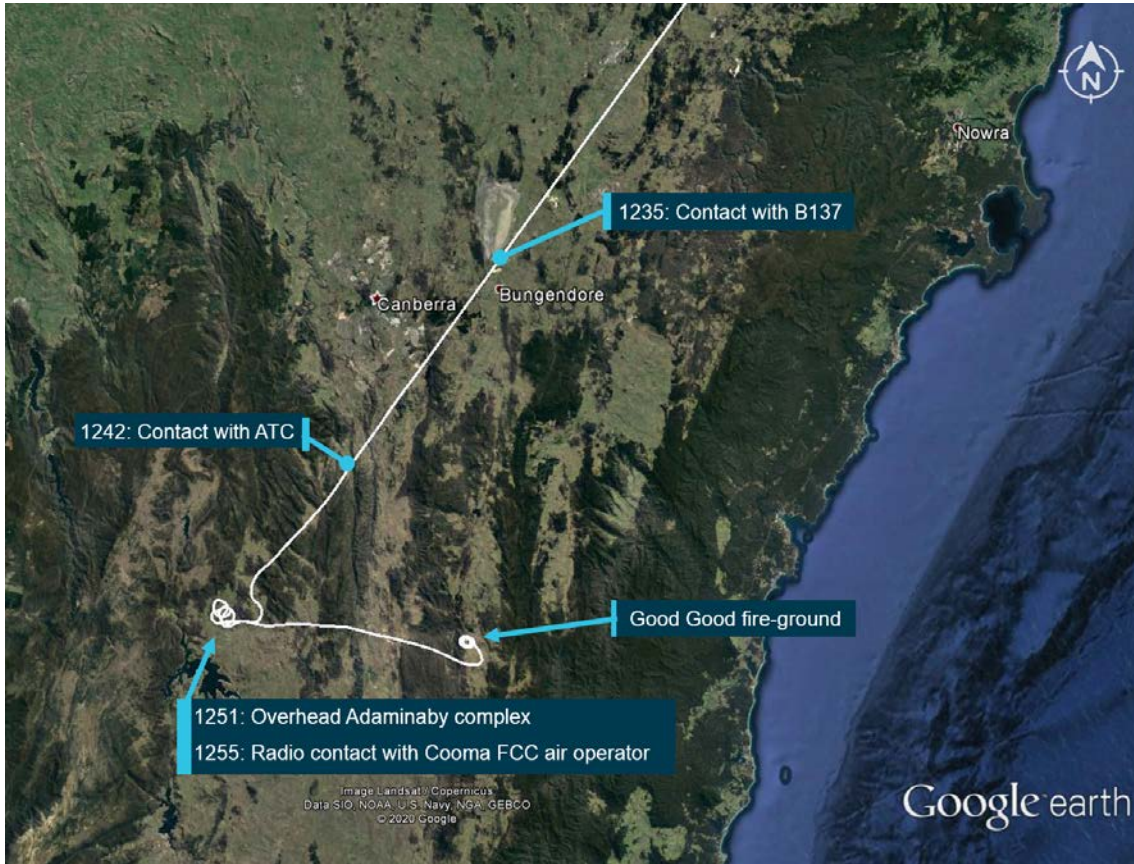
The automatic dependent surveillance broadcast (ADS-B) data showed that after arriving at the Adaminaby fire-ground (Figure 1), the crew of B134 completed several circuits at about 2,000 ft AGL.¹¹ At about 1255, the crew contacted the air operations officer at the Cooma FCC by radio and advised them that it was too smoky and windy to complete a retardant drop at that location. The Cooma air operations officer then provided the crew with the location details (co-ordinates) of the Good Good fire, about 58 km to the east of Adaminaby, with the objective of conducting structure and property protection near Peak View.

Figure 1: Flight path overview (in white), including the times and locations of where the crew of B134 was in communication with others

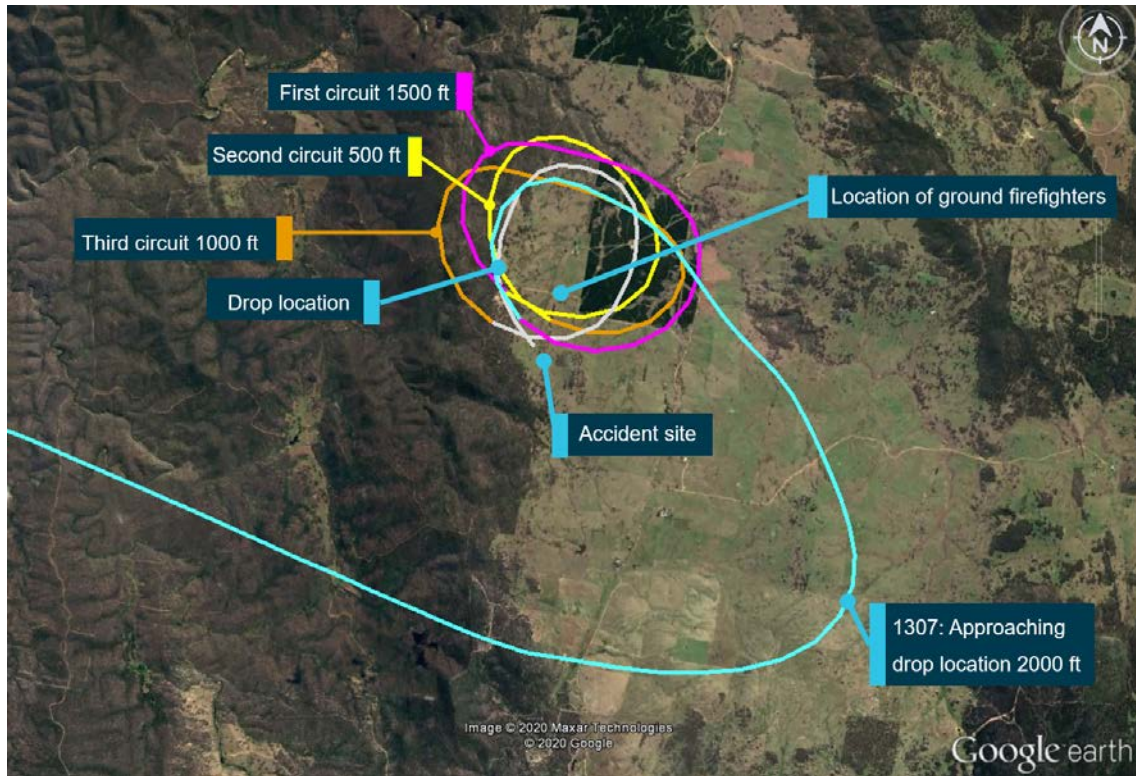
At about 1307, B134 arrived overhead the drop area (Figure 2). From the aircraft’s recorded tracking data, the crew conducted three left circuits, at about 1,500 ft, 500 ft and 1,000 ft AGL respectively, prior to commencing the drop circuit.

Figure 2: B134’s approach and circuits overhead the drop location, and the position of the firefighters

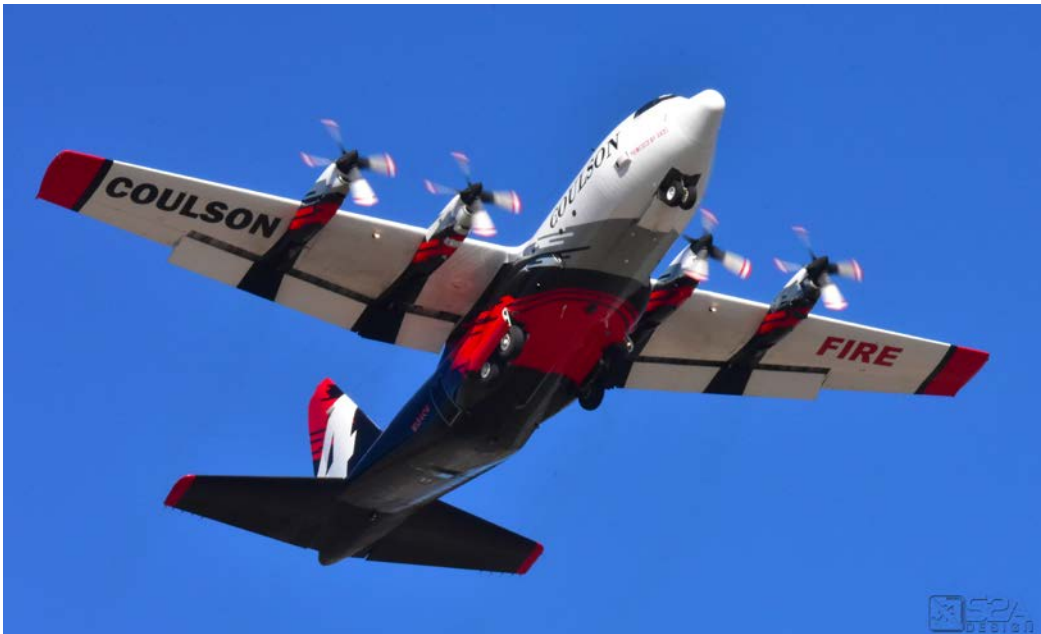
Figure 4: N134CG

The C130 is predominantly an all-metal, high-wing aircraft, designed for military operations. The accident aircraft (Figure 4) was manufactured in 1981 and was powered by four Allison T56-A-15 turboprop engines, fitted with Hamilton Sundstrand 54-H60-91 four blade propellers. The T56-A-15 is a constant speed engine, with a variable pitch propeller.
